Manhole Inspection Summary

Manhole # S13II2001MH

Insp Date: **6/30/06 2:30 PM**

Location Address: **2110 NORTHCLIFF DR**

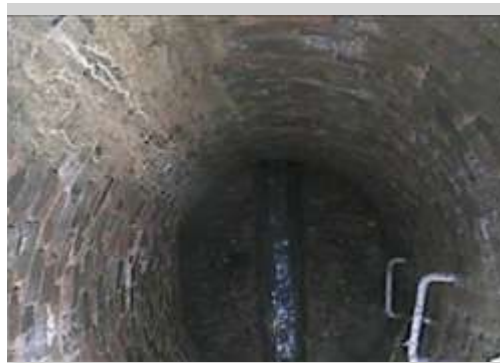
Top View

Evidence of surcharge - Bench debris.
Corroded steps.

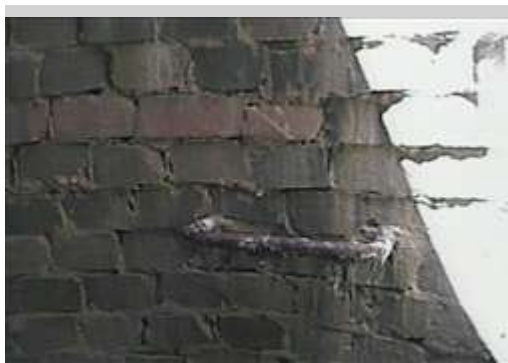
Evidence of surcharge

Mineral deposits from infiltration.

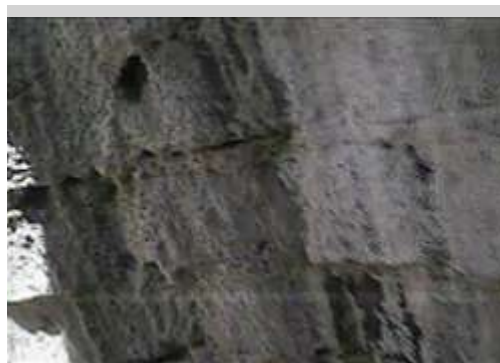
Defect

Frame leaks. Adjustment deterioration
and infiltration. Corbel infiltration.

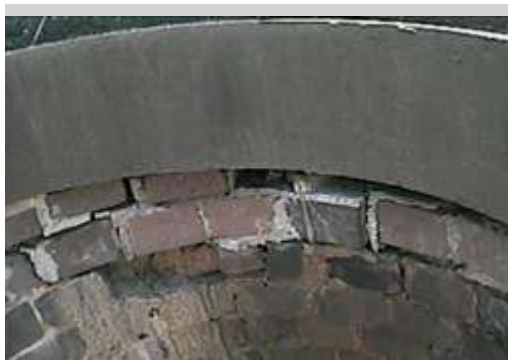
Defect

Adjustment deterioration and infiltration.
Corbel infiltration - other side.

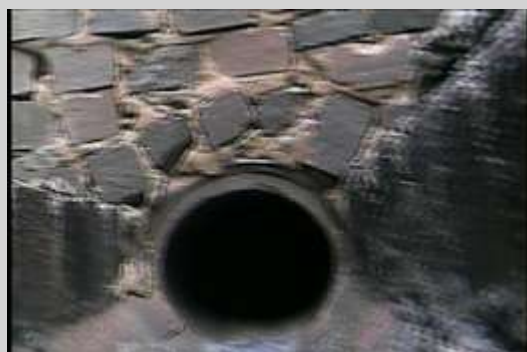
Pipe Out @ 12 O'Clock

Infiltration: **Evidence** Pipe Seal Cond: **Unknown**

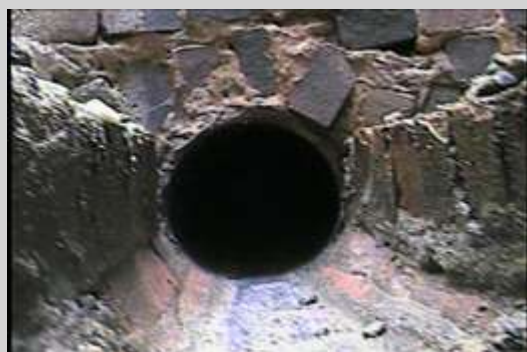
Pipe In @ 6 O'Clock

Infiltration: **Evidence** Pipe Seal Cond: **Unknown**
